MINISTRY OF
MANPOWER

Building and Construction Authority

Circular on Safety Considerations in Gate Design and Operation

Date of Issue	Classification	Circular No.	
1 Mar 2012	Residential & Industrial Gates	OSHD/ OSHI/ MI 043	Page 1 of 8

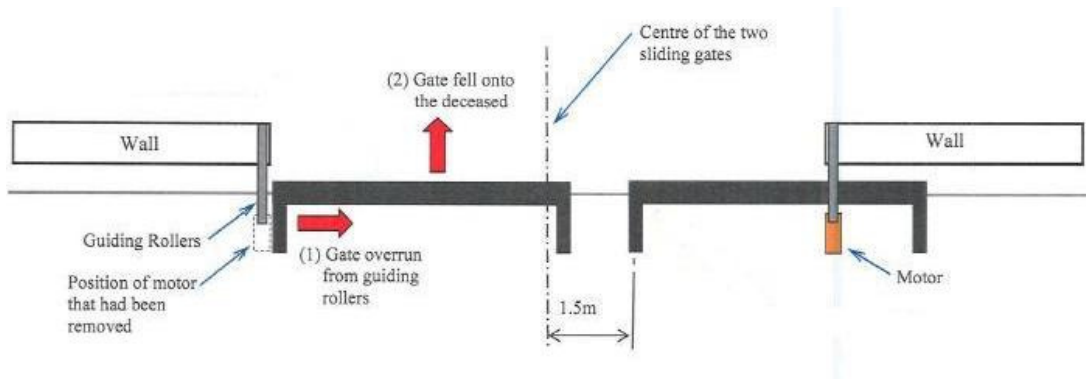
The Deceased, a security officer, was in the process of manually shutting a steel sliding gate leaf when the gate leaf toppled on him, fatally pinning him to the ground. The incident gate leaf was almost 9.7m wide and 2.5m high and weighed about 900kg. The gate was designed to be mechanically operated by remote but the motor which was meant to operate the gate leaf had been removed for maintenance prior to the accident. As a result, the gate had to be manually pushed.

Due to the removal of the motor housing which was also used as a rear stopper, the gate had over travelled. The gate had rollers installed to guide the gate leaf along the rail while outriggers were mounted to prop the travelling gate but both fittings did not serve to prevent the gate from toppling during the accident.

Photo showing the plan view of the incident gate

- D. Housings for motors of electrical gates should be standalone elements and not have dual usage as stoppers or guides for the gates. This is to ensure that the gates remain safe for use in the event the motors and housings are removed for maintenance.

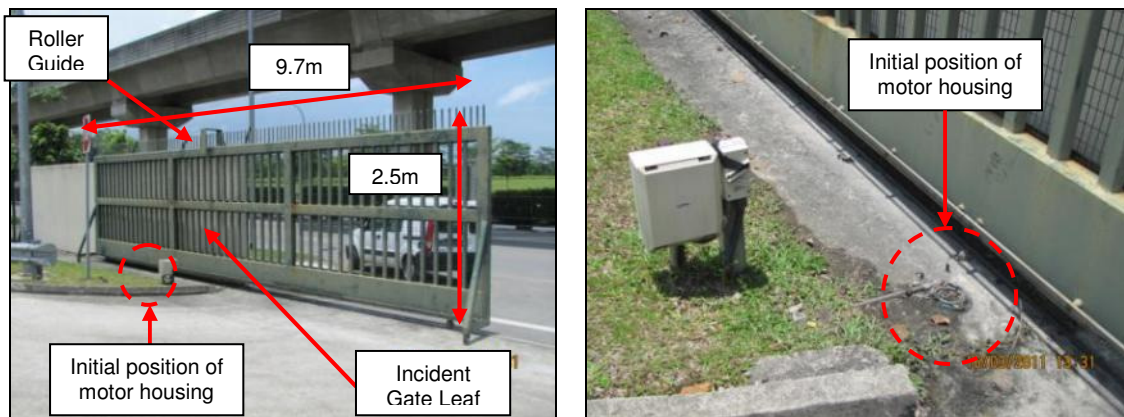
Photos showing the initial location of the rear stopper (Motor housing)

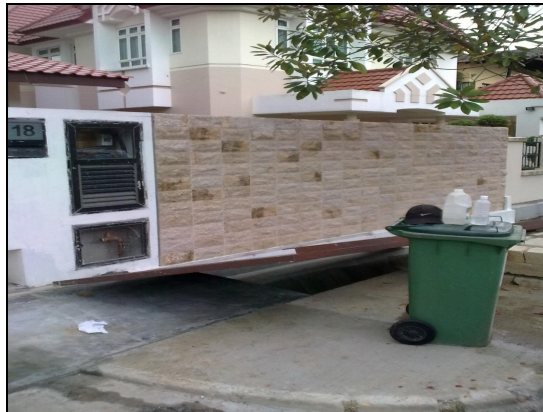
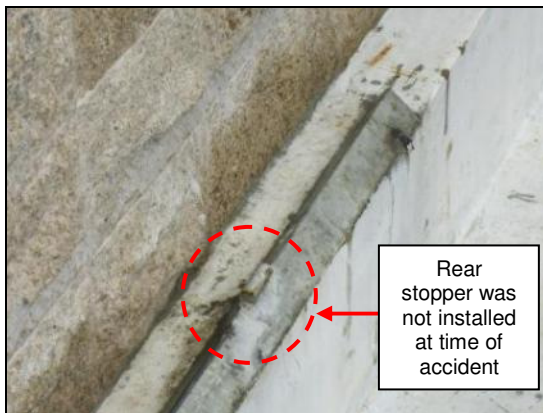
Two technicians were injured when a wooden sliding gate under installation toppled on them. The technicians were surveying the utilities distribution board of a private residential unit when the accident occurred. In order to access the distribution board, the technicians had moved the gate and it toppled on them.

It was found that there were no informative or warning signs displayed near the gate to caution persons that the gate was still being installed. The gate was also not propped to prevent toppling.

Photo showing the toppled incident gate

- A. Installation of gates should be carried out in accordance to the installation sequence as provided by the gate manufacturer.
- B. In the event that the gate has to be left unsecured, it should be propped to prevent toppling. Warning signs should be erected to warn workers and public not to approach the gate.

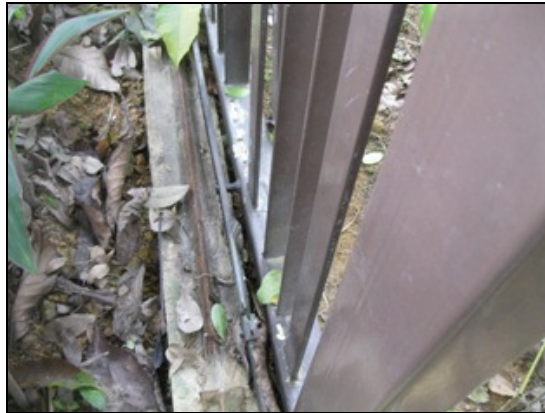
The manager of a condominium was struck by a toppling gate while trying to dislodge the gate which had derailed and was partially embedded in the ground.

Investigations revealed that poor maintenance of the gate caused debris to accumulate on the track, which in turn caused the gate to derail and its wheels were stuck in the soft ground. In a bid to release the gate, the injured pulled hard on the gate, causing the gate leaf to unhinge and subsequently topple on him.

Photo showing the wheels of the incident gate not resting on the track

- D. Gates should be checked and maintained periodically according to the manufacturer's or sub-contractor's recommendation. In addition, the track for the gate should be properly upkept to prevent any accumulation of debris which could cause the derailment of the gates.
- E. All employees operating the gate should be briefed to inspect/check the gate and to ensure proper maintenance.

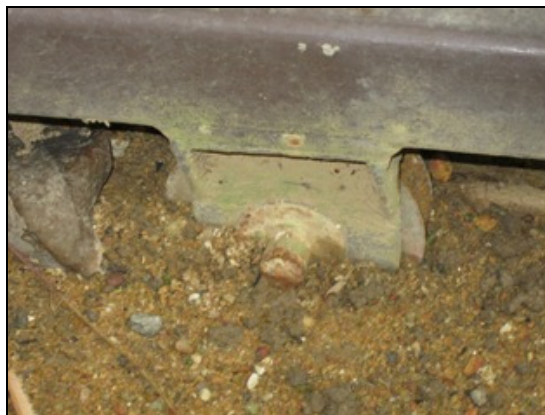
Photo showing one the wheels of the incident stuck in soft ground

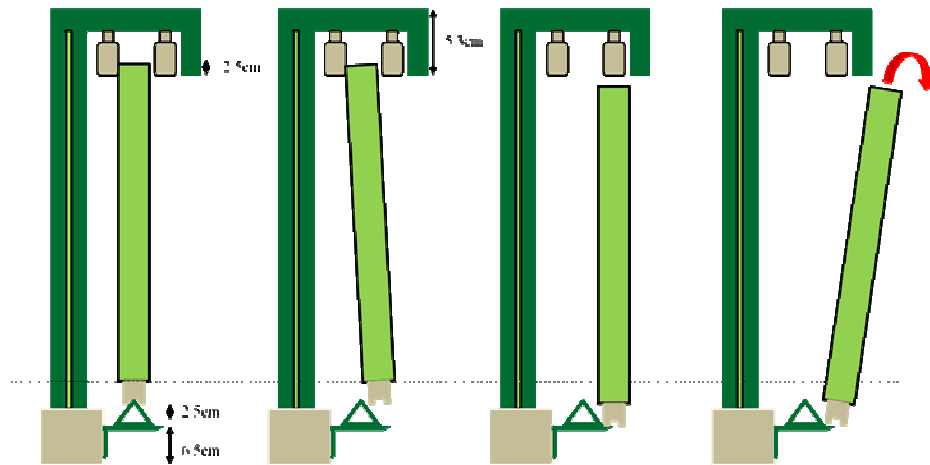
The Injured, a security officer had manually opened a sliding boundary gate when the gate leaf suddenly derailed and toppled, pinning him to the ground. The incident gate leaf was 8.6m wide and 1.9m high. The gate was operated manually and the gate leaf was mounted on two wheels travelling on a rail constructed from a right angle bracket.

The gate was installed with guide rollers and stoppers to prevent the toppling and over traveling. However, the track on which the gate leaf travelled was mounted 70 mm above the ground while the guide rollers which guide the traveling gate only overlapped the gate leaf by 25 mm. Hence, it was inadequate to prevent the gate from toppling once it derailed.

Photo showing the inadequacy of the gate design which failed to prevent the gate toppling

- C. Guides and stoppers should be adequately designed and sized to ensure that the gate will not over-travel nor will it topple in the event of derailment during operation.

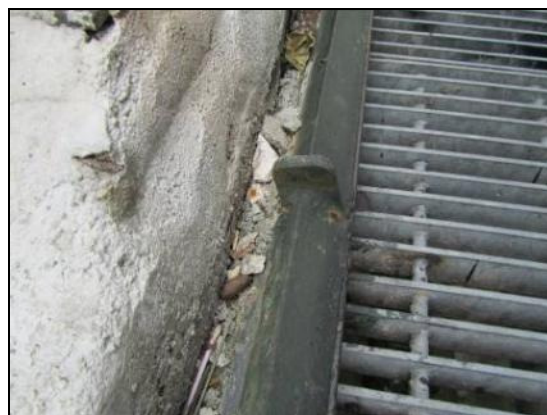
Investigations revealed that the cause of the derailment was due to poor maintenance and a visibly crooked track. The track was littered with concrete debris and litter which contributed to the derailment of the gate.

Photos showing the gap between concrete kerb on the track littered with debris and litters
